Program Bulletin

CUSTOMER SATISFACTION PROGRAM

SUBJECT: Uneven Police Car Rear Tire Wear – Replace Rear Wheel Spindle Rods

MODELS: 2007-2008 Chevrolet Impala
Equipped with Police Package (RPO 9C1/9C3)

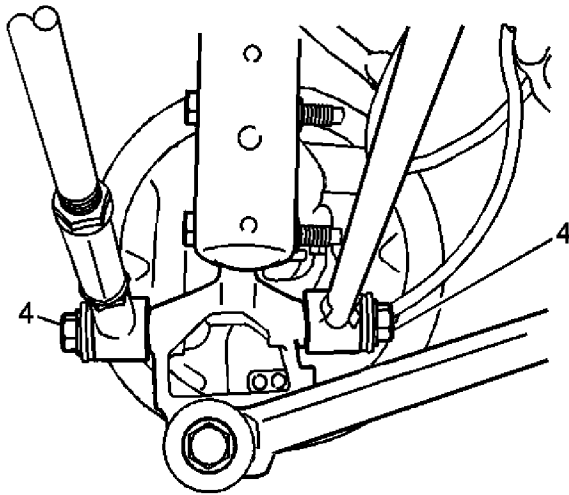
2129076

5. Remove the rear wheel spindle rod bolts (4) and nuts from the knuckles (both sides).
6. Remove the stabilizer shaft from the rear suspension support.
7. Support the rear suspension support with jack stands and remove the mounting bolts.
8. Lower the rear suspension support in order to gain access to the rear wheel spindle rod to support bolts.

15. Install the stabilizer shaft to the rear suspension support.
16. Install the rear wheel spindle rod bolts and nuts to the knuckles (both sides).

Tighten

Tighten the nuts to 150 N·m (110 lb ft).
